ARTEMIS Case Study

Situation

- 10" WI "Unpiggable" Flowline
- 5 areas selected for inspection of corrosion/erosion rate since previous inspection
- 4 mm Polyethylene and FBE coating
- Partially buried

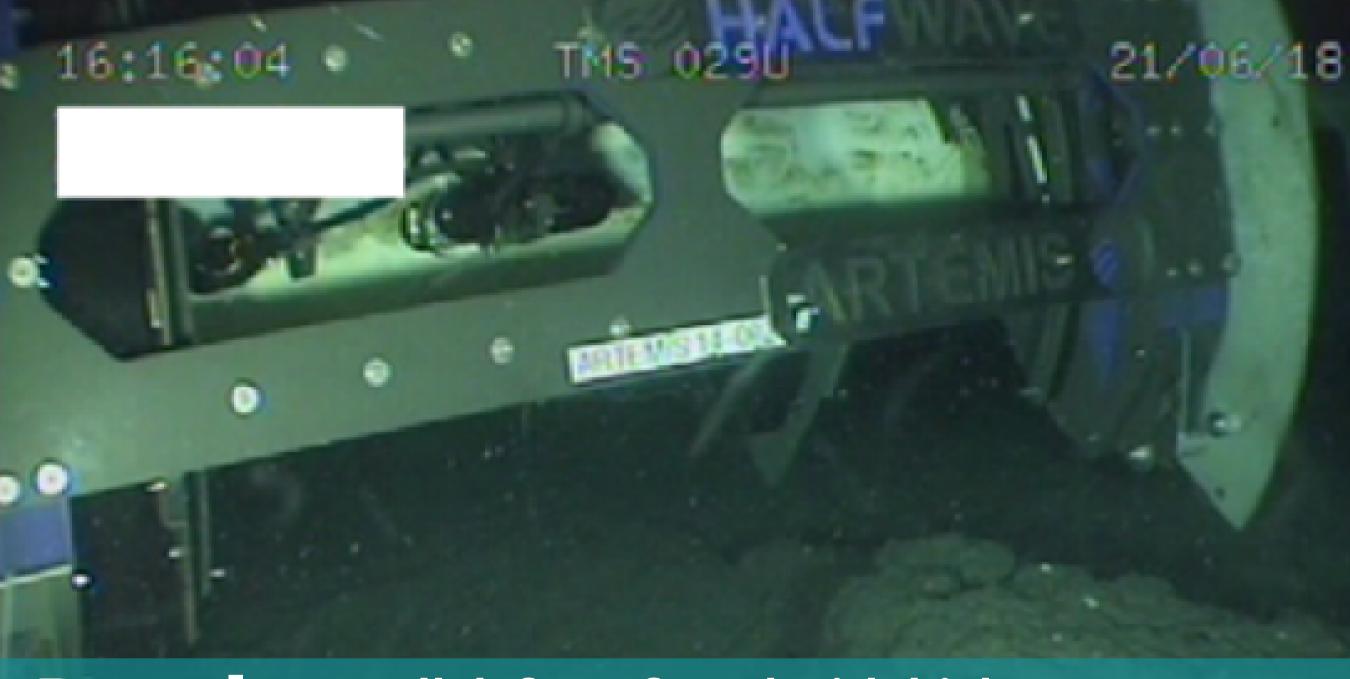
Onshore Blind Testing

All 7 defects found with high degree of accuracy
