CASE STUDY

The Solution for Tight Access Ovality and Wall Thickness Subsea Inspection.

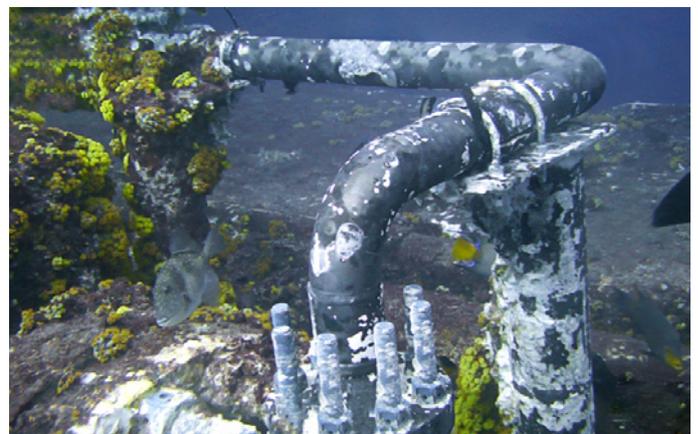
Figure 1: No coating evident. Weld cap can be clearly seen

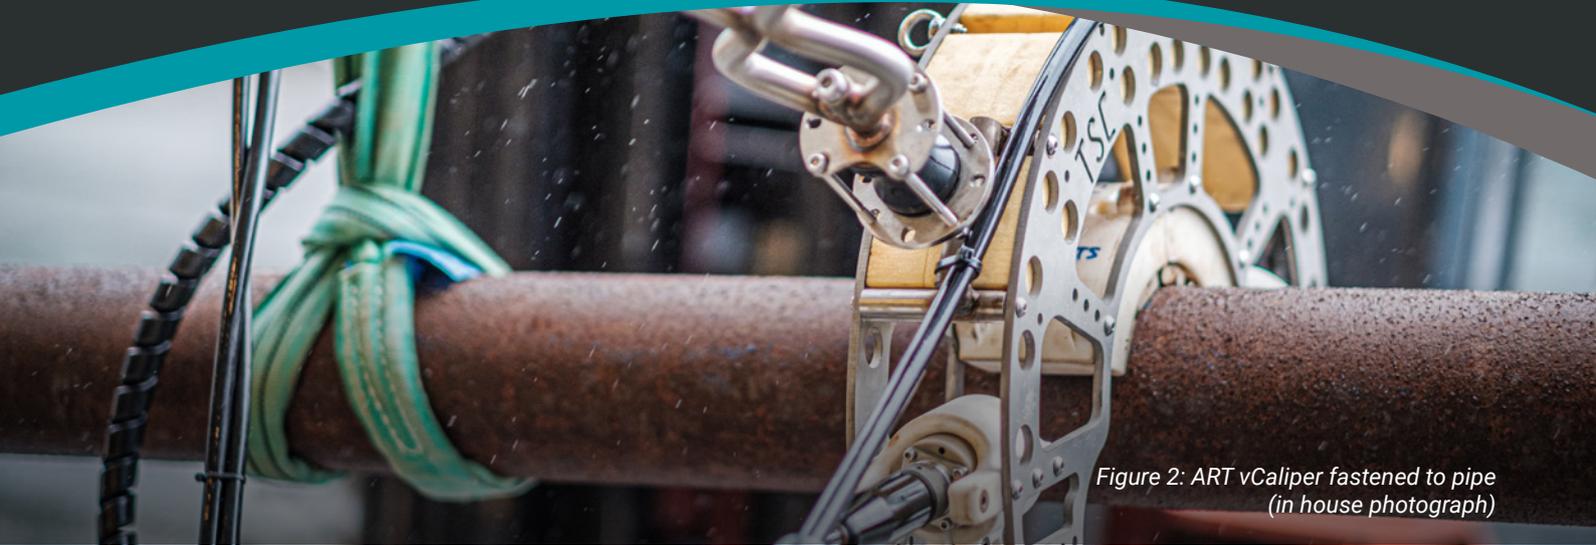
Figure 2: ART vCaliper fastened to pipe
(in house photograph)

The engineering team based the design on aspects of TSC Subsea's NodeScanner™, which uses magnets to fasten to the pipe and engineered the ART vCaliper specifically for this project. It was compact enough to fit into the constricted space and is easily manipulated by the ROV.

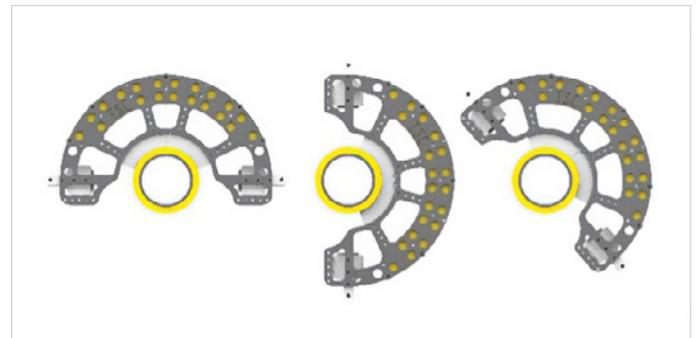
Figure 3: ART vCaliper in different position collecting data.

The tool features two transducers 180° apart, which collect data simultaneously with a minimum collection of 3 readings for ovality.

The current design caters for inspection from 4-20" and can be engineered to any diameter required. It easily interfaces with all common ROVs, and is lightweight, using a magnetic motorless arc to fasten on to the pipe. It provides full 360° coverage around the pipe with simple manipulation by an ROV.

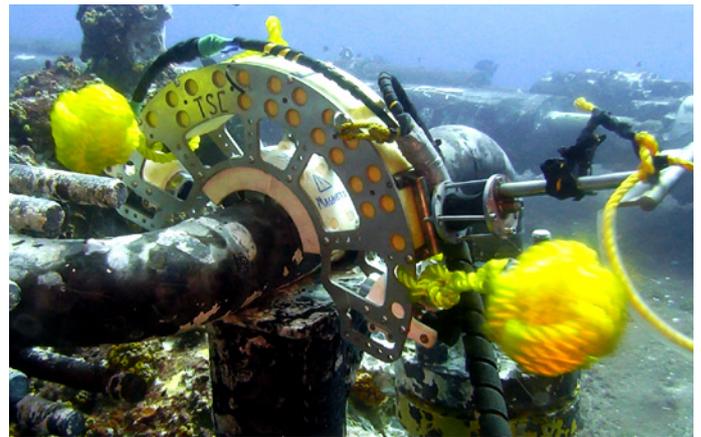
The inspection was successfully carried out and determined that the pipe work at the site of the proposed hot tap was free from excessive corrosion and was sufficiently round for the hot tap procedure to go ahead. The results from the ACFM® crack detection confirmed no significant defects at the inspection points.

Figure 4. ART vCaliper performing inspection underwater.

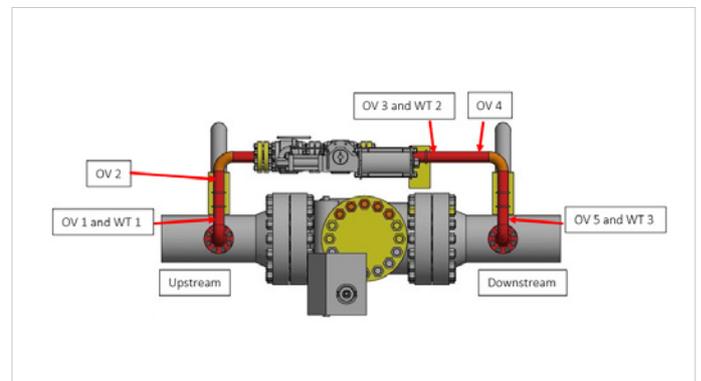
Figure 5. Completed Inspection Locations
