The ART of Subsea Grout Integrity

Grout integrity verification of subsea structures is now possible thanks to TSC Subsea's innovative technology and the development of its unique solution, the ART GUIDE scanner.

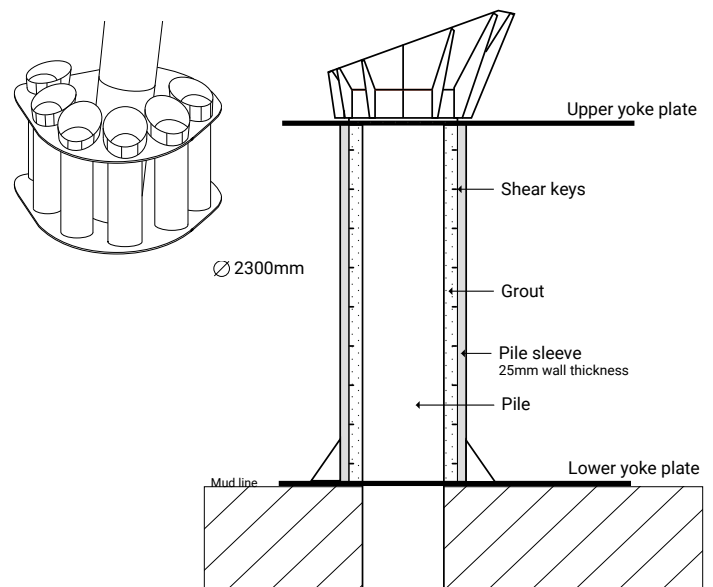
Such inspections aim to verify the grouting integrity behind the pile sleeve and look for features and inconsistencies, such as voids, crushing and cracks in the grout, behind the pile sleeve and dis-bonding between the pile sleeve and grout, which may have developed over time in subsea grouting connections.

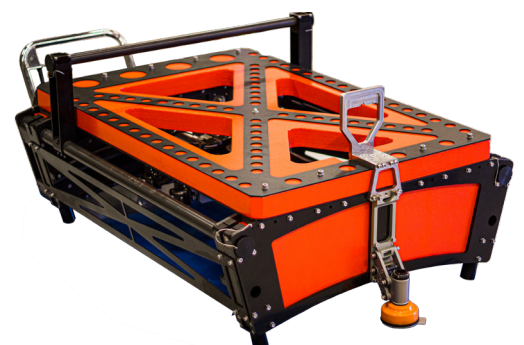
TSC Subsea deployed its Acoustic Resonance Technology (ART) for this project. ART is a frequency-based acoustic inspection method specifically suited for detecting the various failure modes found both in the steel and the grouted structure in the annulus.

For this campaign, TSC Subsea specifically developed the ART GUIDE, an acoustic scanner which is magnetically attached to the structure by a work class ROV (WROV).

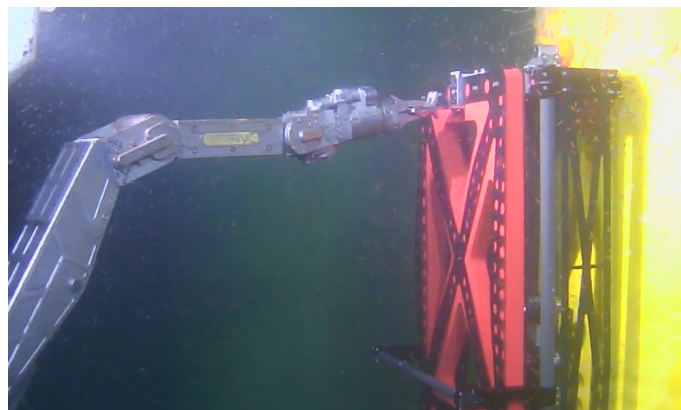
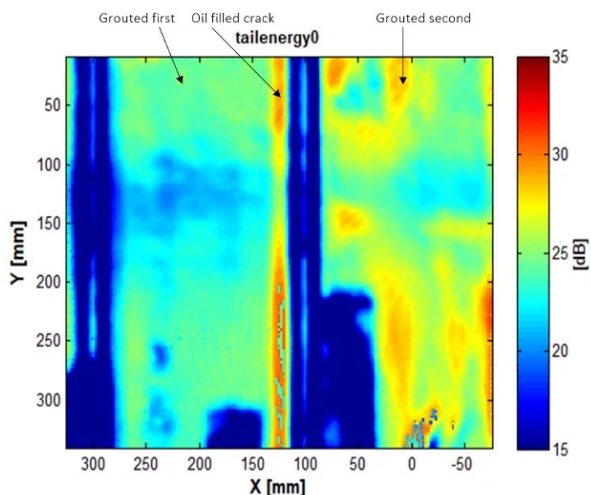
The ART Guide system is designed with specific attachments that can be interchanged to facilitate the inspection of various pile sleeve diameters.

Using multiple sensors, it can scan a 0.5m x 0.5m window in 20 minutes, typically taking a shift to inspect an Ø3m diameter leg.

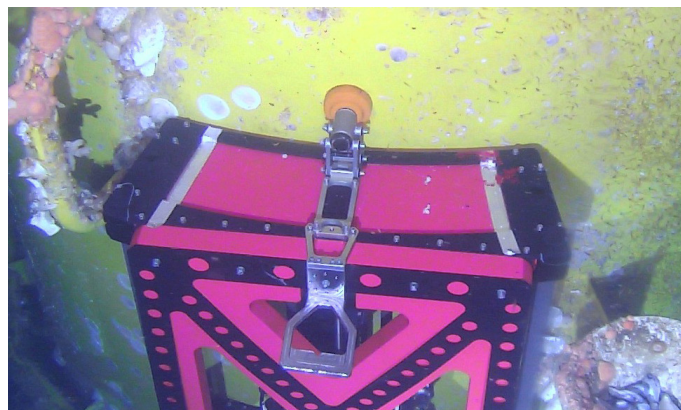
While cleaning to remove hard marine growth is required by industry standard tools before an inspection, the technology is not affected by soft marine growth and can scan through thick layers of painted surfaces.

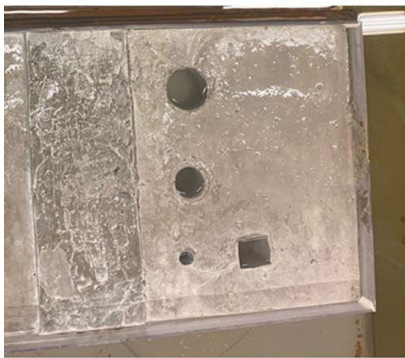
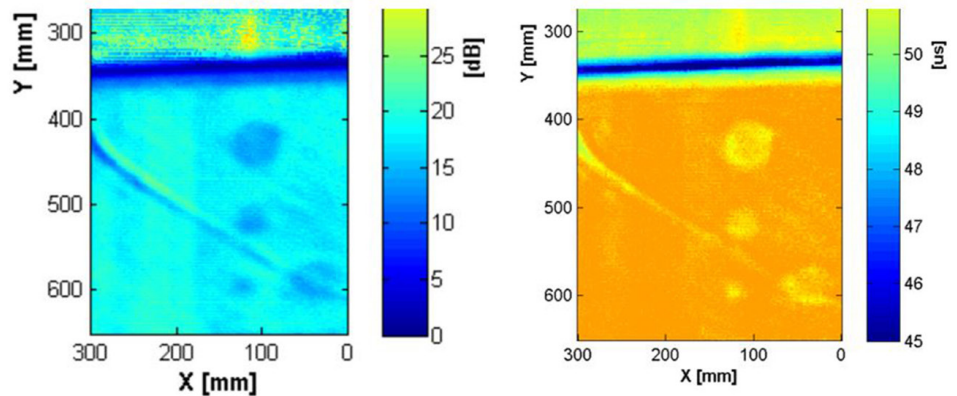
The operation requires the ART GUIDE scanner to be magnetically attached to the pile sleeve surface, allowing the scanning operation to be conducted uninterrupted.

A combination of effective buoyancy and magnetic force allows the WROV to easily deploy and reposition the ART GUIDE in cases where multiple scans are required.
