Flooded Member Detection (FMD) of Complex Riser Caisson with Acoustic Resonance Technology (ART)

THE CHALLENGE

TSC Subsea received a request from Ocean Infinity on behalf of Orsted, a Danish multinational energy company, to perform a comprehensive Flooded Member Detection (FMD) inspection on a Riser Caisson. The purpose was to ascertain whether seawater had infiltrated the caisson or if it remained dry, as per the original system design.

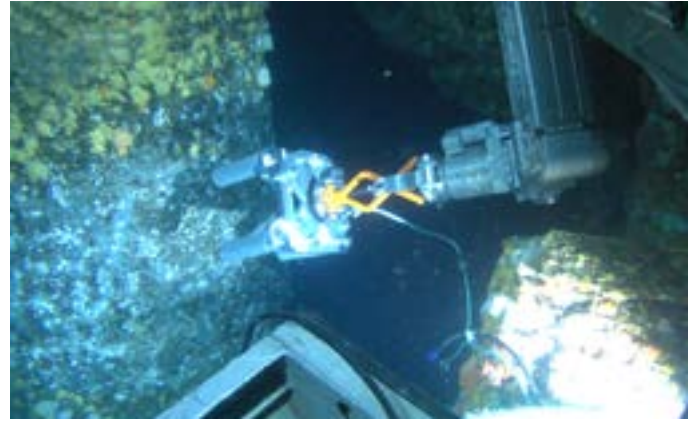
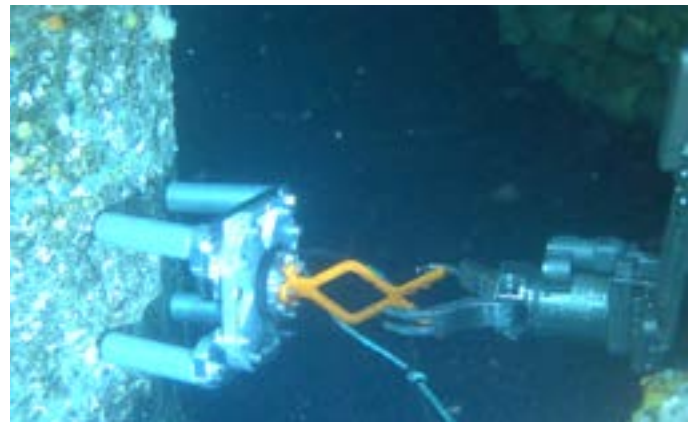
The offshore operation commenced with a Site Integration Test (SIT) to verify power, communications, and data acquisition software between the Remote Operated Vehicle (ROV). The first inspection took place approximately 500mm from the lowest bend of the caisson, with a second inspection at a higher elevation to establish a reference point where air behind the member wall was more likely.

The ROV's manipulator deployed the ART FMD inspection tool to the first inspection area. A simple mechanical assembly maintained the correct sensor standoff distance, with magnetic legs ensuring optimal acoustic angles. Fifteen scans were conducted at the first location around the caisson's external wall, followed by two additional scans at the second location.

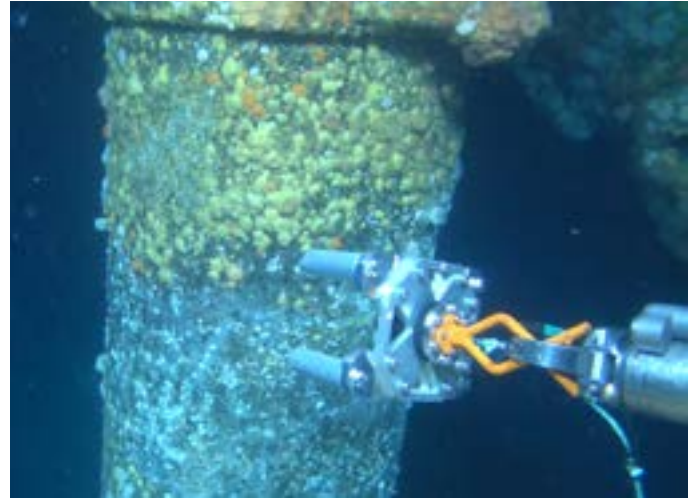
The Flooded Member Detection (FMD) inspection was a success. The combination of ART technology and TSC Subsea's highly effective, efficient FMD tool proved to be the most dependable solution available.

The comprehensive inspection confirmed that the caisson remained dry, ensuring the asset owner's confidence in its integrity.
