# Diverless Bilge Keel Weld Inspection with Subsea Robotics and ACFM®.

Within the framework of a DNV UWILD program, our client embarked on a quest for a suitable inspection technology and a diverless deployment method to examine the bilge keel welds of FPSOs.

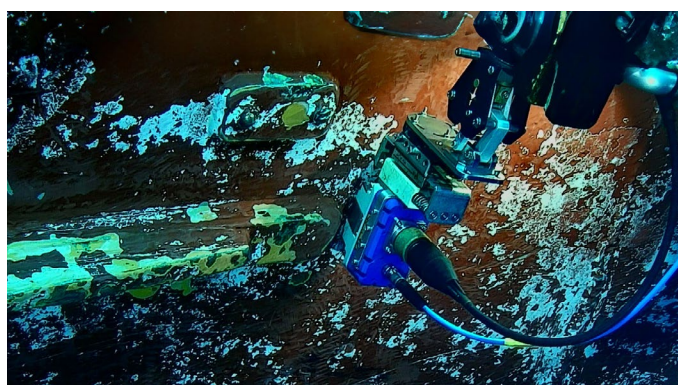
Transported to the FPSO's hull by a Remote Operated Vehicle (ROV), the MagCrawler was securely attached using its powerful magnets. After ensuring a secure attachment, the ROV released and positioned itself to observe the inspection. The TSC Subsea operator, situated safely in the control room, manoeuvred the crawler into position. The inspection commenced with the first pass at the weld, followed by subsequent passes, each overlapping to guarantee 100% coverage.

-   Hull Weld Toe / HAZ
-   Cap
-   Bilge Keel Weld Toe / HAZ (when available)

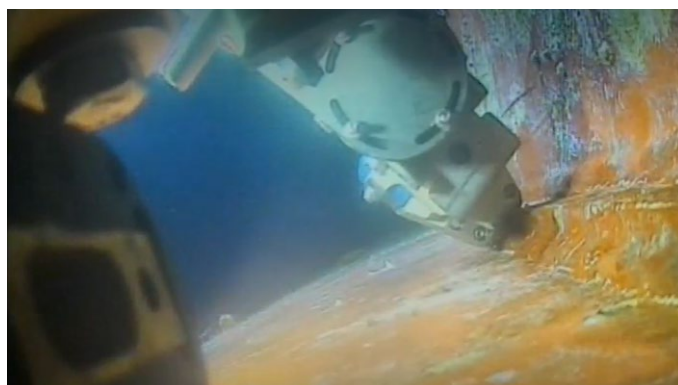
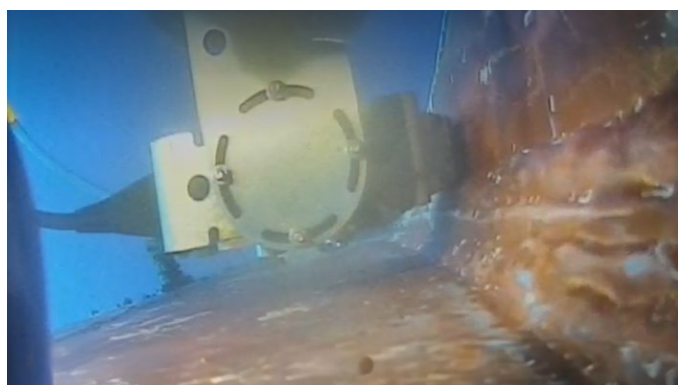
The inspection proved successful, with all bilge keel welds examined within the designated time frame. No surface-breaking cracks or defects were identified above the reporting threshold of 20 mm in length and 2 mm in depth.

The utilisation of the ROV-deployed robotic solution led to a swifter and more efficient inspection in comparison to a diver-deployed approach, as the robots faced no time constraints while in the water. Additionally, the crawler's consistent and controlled scan speed contributed to more reliable inspection data, ensuring a higher probability of detection (POD).
