# Smooth Sailing with ACFM® Crack Assessment on Cargo Ship Propellers.

The Archon Gabriel Bulk Carrier was navigating the cold waters of the Gulf of Finland. The harsh sea conditions, laden with sea ice, posed significant navigational challenges and resulted in the ship's 6-meter diameter bronze propeller suffering ice damage.

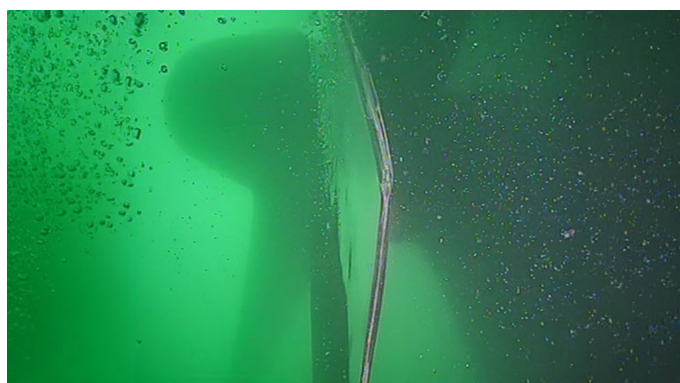
Propeller showing the trimmed edges

Following an initial visual inspection by Seawide Services, it was decided to trim approximately 270 mm from the propeller's edges. However, this did not ensure the complete removal of ice-induced cracks, prompting the advice for TSC Subsea to conduct an ACFM inspection.

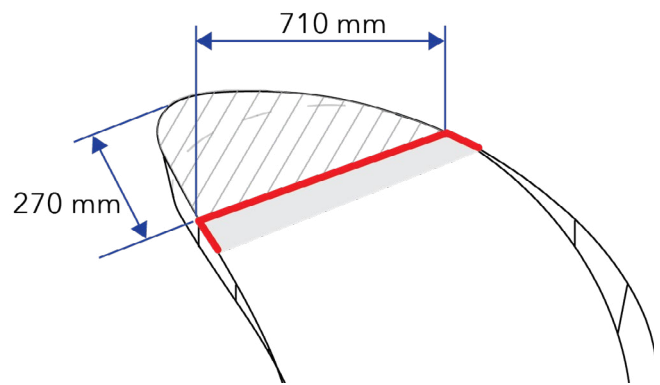
Propeller showing the trimmed section

The inspection scope involved scanning the full length of the recently cut edges of four propeller blades, each approximately 715 mm, and a short section on either side of about 50 mm. The propeller blades were cleaned to a suitable standard before the inspection.

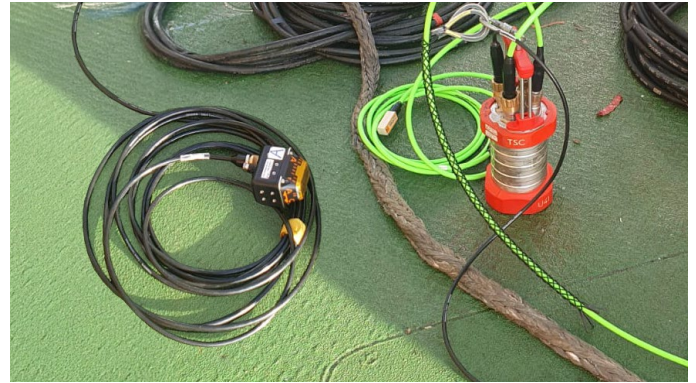
ACFM equipment: U41 and array probe

The inspection system included TSC Subsea's U41 ACFM technology bottle and two ACFM probes, an array probe and a pencil probe, and a direct connection to the ACFM Level 2 analyst who remained topside.

A unique feature of the U41 system is that two probes can be connected to it simultaneously. This means the diver does not have to resurface to swap probes, which improves overall inspection efficiency.

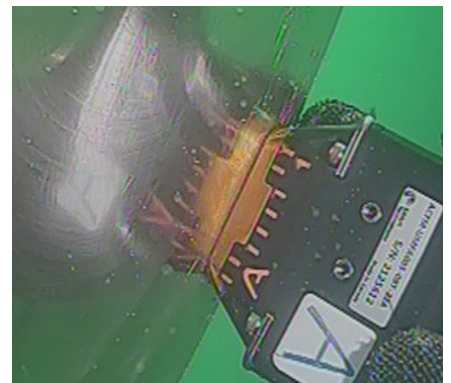
ACFM array probe scanning

**Array Probe:** Each blade was inspected on both the pressure face and the suction face, with 5 scans carried out on each face.

Scans 2 and 4 overlapped the start and end of Scan 1. Each scan involved 2 passes, one with the probe edge on the blade edge and another with the probe centre on the blade edge. All scans were conducted in the "T" direction.

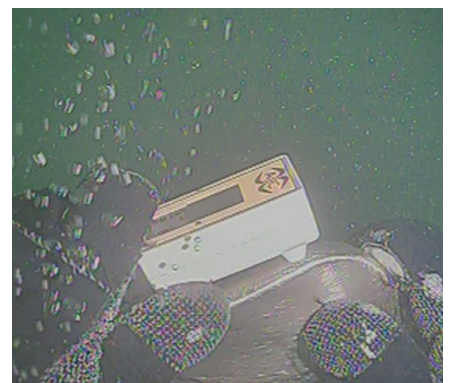
ACFM pencil probe scanning

**Pencil Probe:** The pencil probe was used to scan the three edges (blade tip, leading edge, and trailing edge) of each blade. All scans were conducted in the "T" direction.

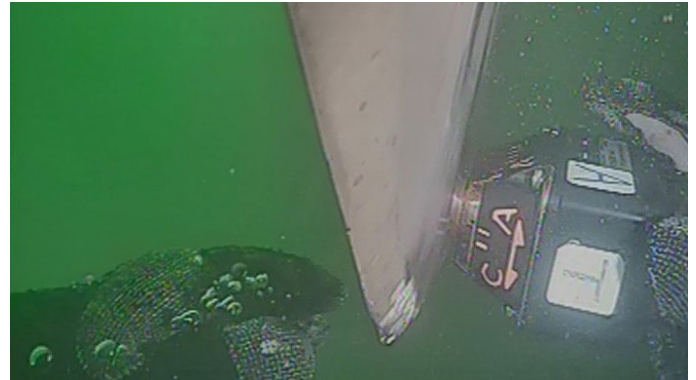
Diver scanning the propeller with an ACFM array probe

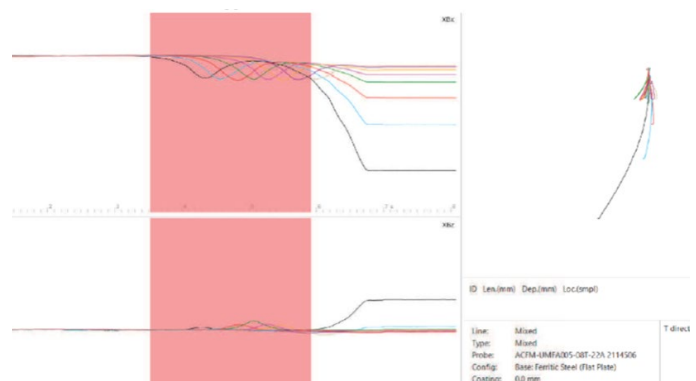
ACFM signal from a transverse scan

Due to bronze's lower magnetic permeability compared to steel, a transverse signal would be absent or significantly smaller when scanning in the "A" or "C" directions. Consequently, detection scans were performed in the Transverse (T) direction

Throughout the inspection, detection scans exhibited a high signal-to-noise ratio due to the quality cleaning, slow and controlled scan speed, and smooth weld profiles. This suggests that surface-breaking defects at or above 20 mm long x 2 mm deep would have been reliably detected during this inspection campaign.

The inspection was conducted within 1 day, and no reportable defects or cracks were detected above the reporting threshold. The swift deployment and efficient inspection minimised downtime, allowing the vessel to resume within 48 hours after entering the port. By confirming the absence of significant cracks, unnecessary repairs or replacements were avoided, resulting in substantial cost savings.
