# CASE STUDY:

## vCompact™ in Action: Corrosion Mapping & Weld Integrity Assessment of Subsea Pipelines

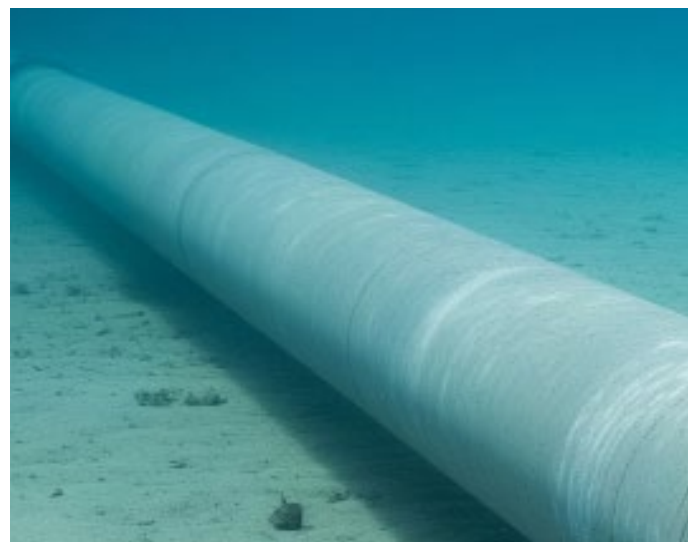
Subsea Pipeline with Concrete Weight Coat (CWC)

The pipelines were protected by a concrete weight coat (CWC), with a layer of polyethylene which were removed by another contractor, leaving the surface to a SA2.5 standard.

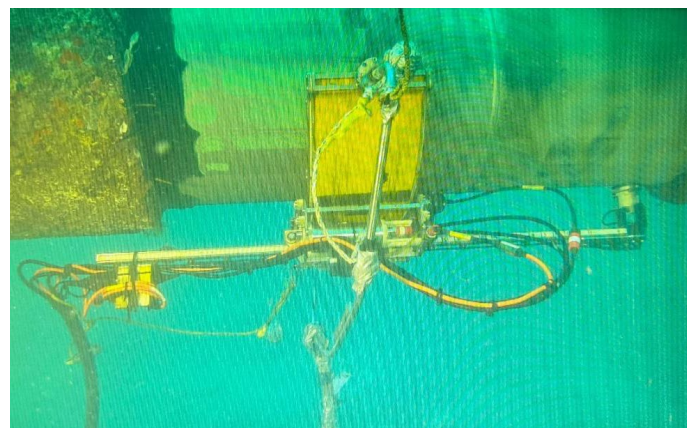
vCompact™ in SPA™ mode

**Phase 2: Subsea Phased Array (SPA™):** The vCompact's motorised scanning arm extends to 550 mm with 64 axially aligned probe elements, maximising coverage and resolution for corrosion, erosion, and damage mapping. It performs a circumferential scan, retracts 50 mm, and repeats until fully retracted. The ROV then rotates the scanner to repeat the process around the pipe. Smaller pipes require two rotations; larger ones need three for full coverage.

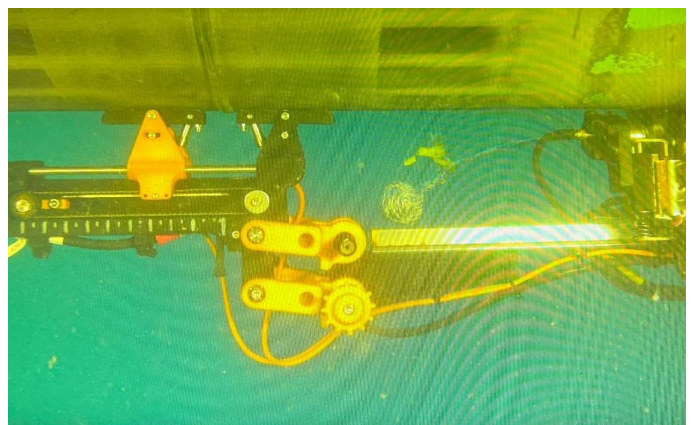
vCompact™ in ToFD mode

**Phase 3: Time-of-Flight Diffraction (ToFD):** For weld inspection, a dedicated add-on attaches to the vCompact's retractable arm. This enables operators to adjust the probe-centre separation (PCS) remotely from the control room, without resurfacing. As optimal PCS varies with wall thickness, incorrect settings can degrade sizing accuracy. When a flaw is detected, the robotic arm fine-tunes the PCS on the fly to adjust the ultrasonic focal point, ensuring accurate defect positioning and sizing.
