CASE STUDY:

ARTEMIS®: Through-Coating Inspection for Large-Diameter Subsea Pipelines.

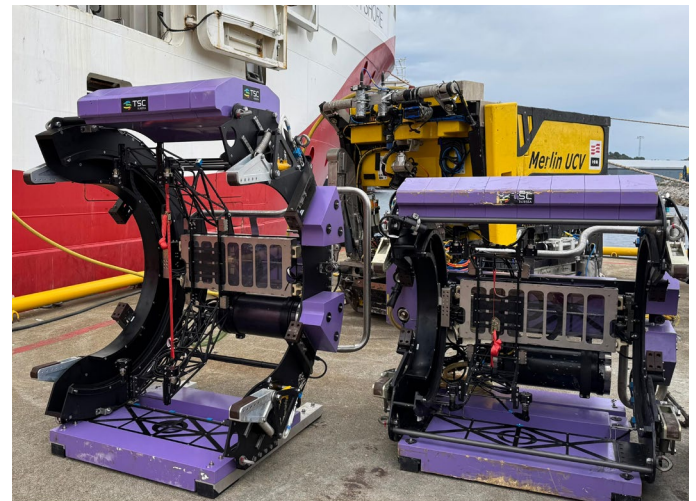
ARTEMIS® XL and Standard ARTEMIS® Systems

The system provides 700 mm axial coverage and full 360° inspection per placement. It achieves this using four transducers mounted on two arms positioned 180 degrees apart. Each arm holds two transducers. With a 180-degree rotation, full circumferential coverage is completed.

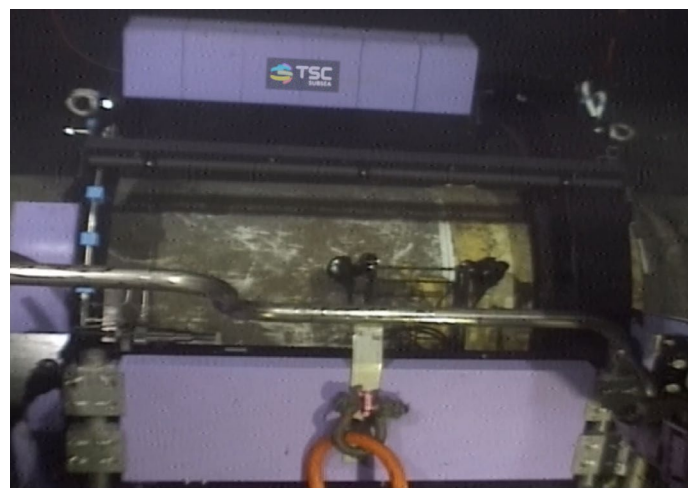
ARTEMIS® Performing Full 360° Circumferential Inspection

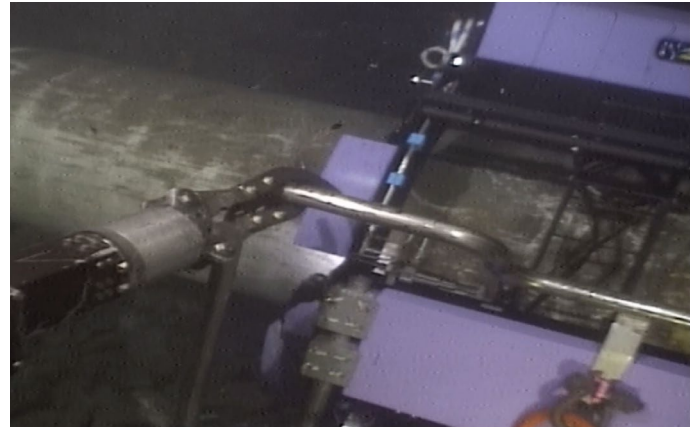
ROV Manipulator Positioning the ARTEMIS® on the Pipeline

Deployment: The ARTEMIS system was deployed using a Merlin WROV via the wet-mate method. The ROV connected to the tool using its manipulators to activate hydraulic and power systems. The tool was handled using grab bars, allowing the ROV to move freely in strong currents without disturbing the inspection. After each scan, the ROV repositioned the tool for the next scan or transferred it to a new inspection location.

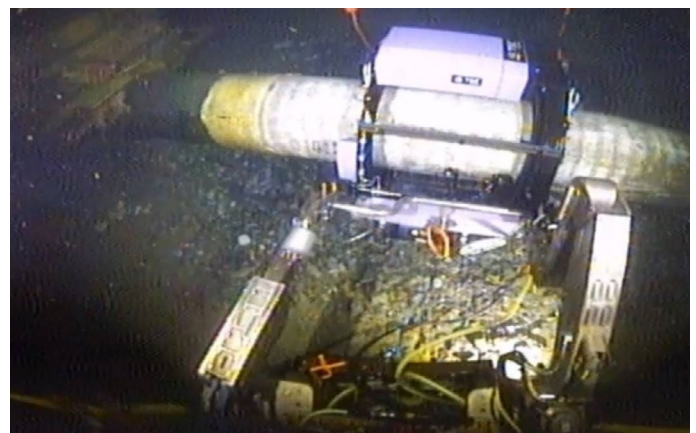
Pipeline with 0.3 mm FBE and 7.7 mm PP coatings

ART does not have these limitations and can inspect through highly attenuative coatings, including the 7.7 mm polypropylene used on these pipelines. Only minimal surface preparation was required to remove marine growth using the ROV's high-pressure water jet, with no coating removal necessary. This significantly reduced vessel time and operational complexity while maintaining high data quality.

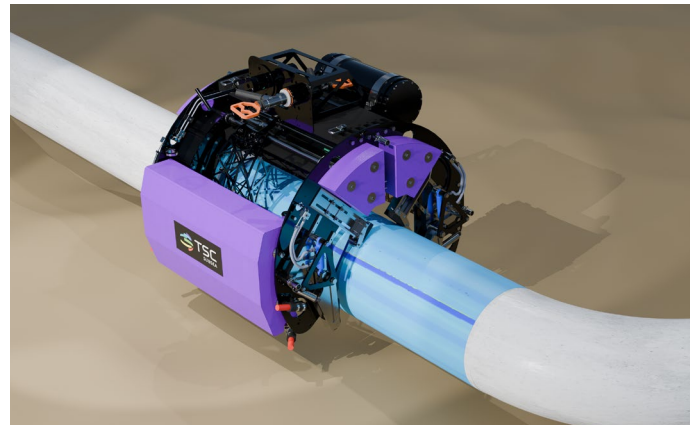
3D Model with ART Wall-Thickness Data Overlay, Showing Seam Weld as Dark Line
