## Subsea Pipe-in-Pipe (PIP) Integrity Assessment Using ARTEMIS® & ART

An offshore operator in the South China Sea required a detailed integrity assessment of a deepwater pipe-in-pipe (PIP) flowline consisting of a 12-inch inner production pipe housed within an 18-inch outer carrier pipe, with thermal insulation installed within the annulus.

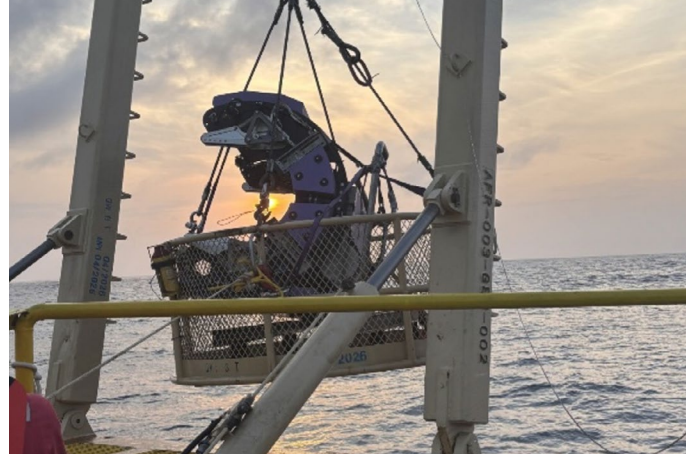
ARTEMIS in deployment basket

ARTEMIS® was mobilised offshore in a dedicated subsea deployment basket and lowered to the seabed. A work-class ROV recovered the system and completed the subsea connections using hydraulic hot stabs and wet-mate electrical connectors before transporting ARTEMIS® to the first inspection location. At each location, the system was clamped to the carrier pipe to complete the circumferential scan, then released and transferred to the next location.
