Innovative Approach to Combined Wall Thickness Measurements and Ovality/ Dent Mapping on Subsea Pipelines.

Anchor Damage on Subsea Pipeline

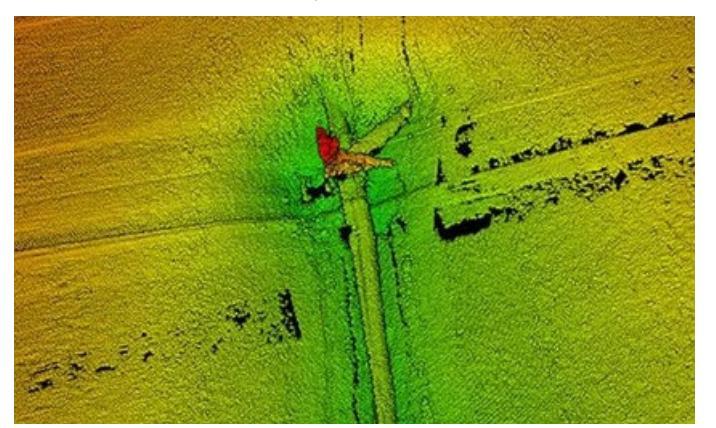
The anchor was discovered during a pipeline jet trenching campaign using a multibeam sonar system, producing a 3D image of the pipeline and the abandoned anchor on the ocean bed.

Although the area was marked as a no-anchor zone, prohibiting vessels from deploying anchors, an unscrupulous individual disregarded the restrictions and dropped their anchor. Regrettably, for the client, the lack of markings on the anchor posed a challenge in identifying its owner.

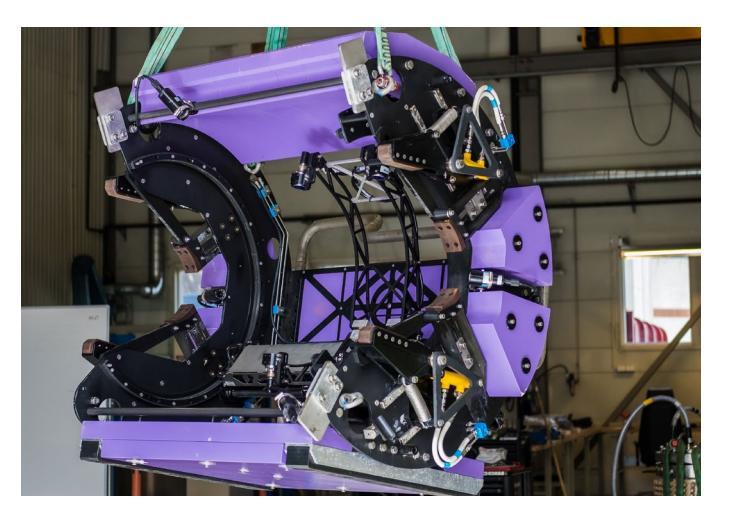
To deliver this remarkable technology, TSC Subsea had several choices of diverless robotic scanners capable of performing the task. The decision was reached that their ARTEMIS represented the ideal ROV deployable solution, requiring only 300 mm (12 in) of access beneath the pipe and capable of accommodating the piggyback line, thereby providing maximum achievable circumferential coverage.

The selection of ARTEMIS was further justified by its stability when attached to the gas pipeline. The unique clamping mechanism of ARTEMIS ensures it maintains a fixed, stable position. At the same time, the four non-contact ART sensors remain vertically fixed but possess the capability to move horizontally, covering distances of up to 700 mm (28 in). This allows for a comprehensive 360-degree x 700 mm (28 in) inspection area from a single position in normal operating conditions.

ARTEMIS

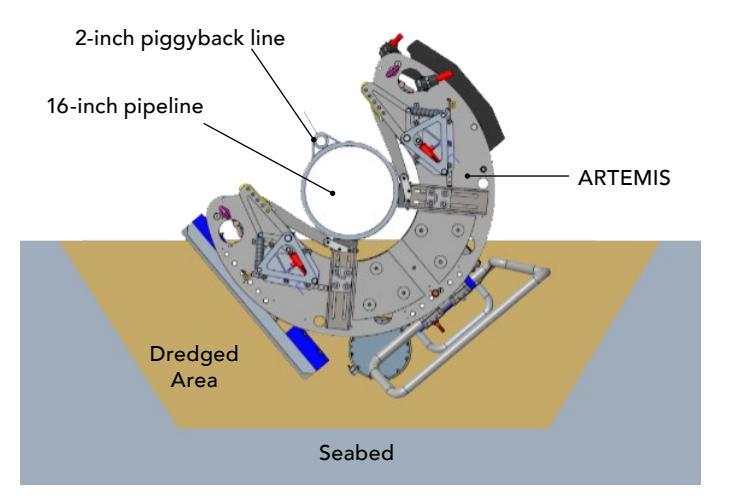
ARTEMIS offers various deployment methods, and for this particular operation, a wet-mate system was employed due to the vessel's ROV deployment capabilities. This involved placing ARTEMIS into a basket, which was then lowered to the seabed via a crane. Subsequently, the ROV connected the Tronic and Hydraulic stabs, utilising their manipulator function before deploying ARTEMIS to the inspection locations.

ARTEMIS deployment position

ARTEMIS covers a scan length along the line's axis of 700 mm (28 in). Three scans were conducted, each with an overlap of approximately 100 mm (4 in), to ensure maximum coverage. Due to the presence of the 2-inch (50 mm) piggyback pipeline, the tool was deployed onto the pipeline at the 4-5 o'clock position, allowing for an impressive 290-degree coverage.

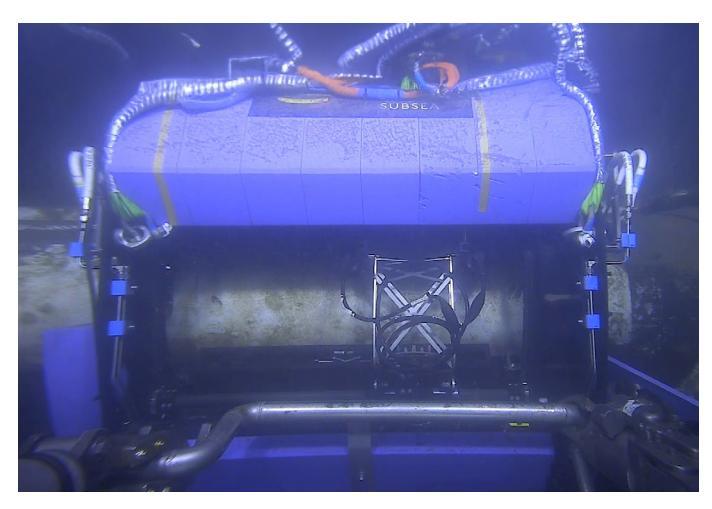
ARTEMIS in operation

ARTEMIS, rated to 300 bar and capable of diving up to 3000 m (10,000 ft), effortlessly handled the 30 m (98 ft) depth. With two arms 180 degrees apart and each arm accommodating two ART transducers, ARTEMIS is capable of full circumferential coverage with only a 180-degree rotation.

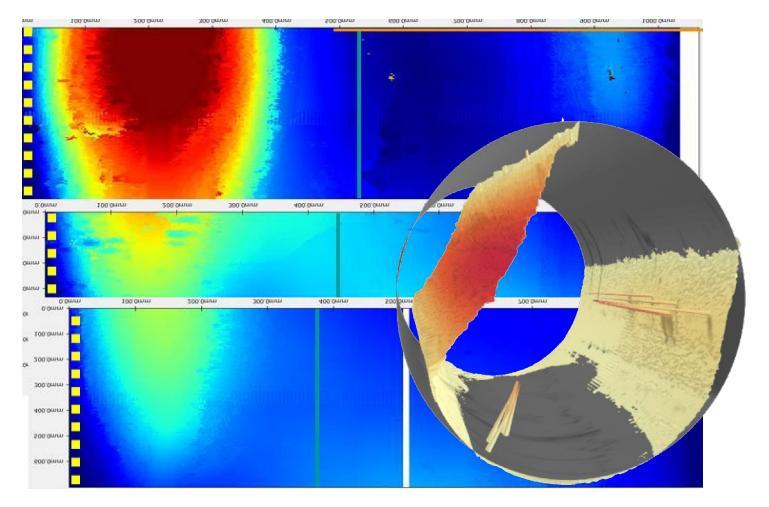
No wall thickness loss was identified above the specified reporting threshold. However, a substantial geometric feature indicative of a dent was observed, spanning from the 11 o'clock position to the 6 o'clock position, with a depth measuring 111 mm (4.4 in) at its lowest point.

Colour-coded C-scan and 3D model detailing the severity of the dent.

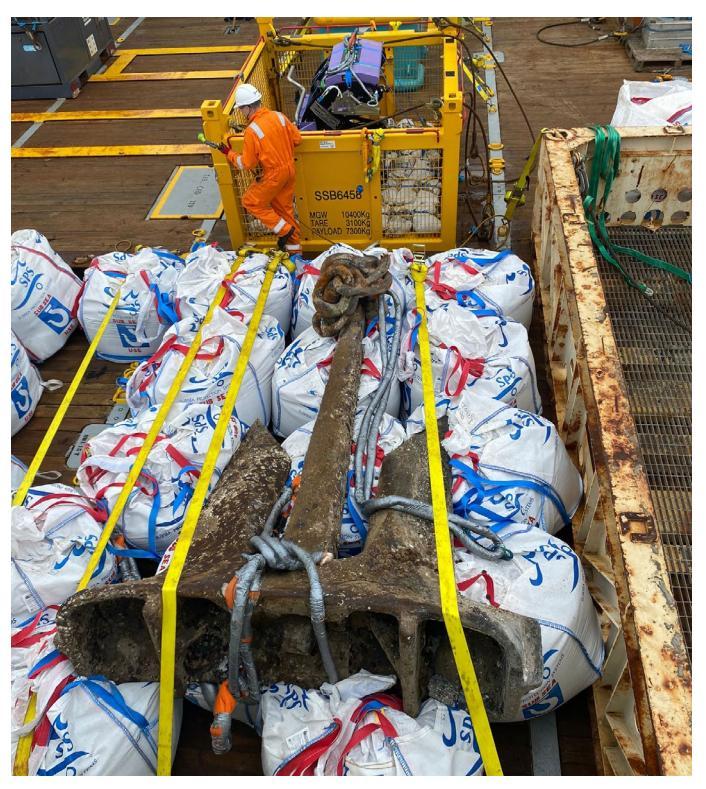
Before the inspection, a subcontractor was tasked with removing the anchor and dredging a small amount of the seabed beneath the pipeline.

Back onboard - ARTEMIS and recovered Anchor
